## Removal of oil pollutants and subsequent sinking, MV Nella Dan

Macquarie Island  
10-27 December 1987

Report of Assignment to Macquarie Island to attend stranding of MV NELLA DAN.  
Condensed and Verbatim as per official report.

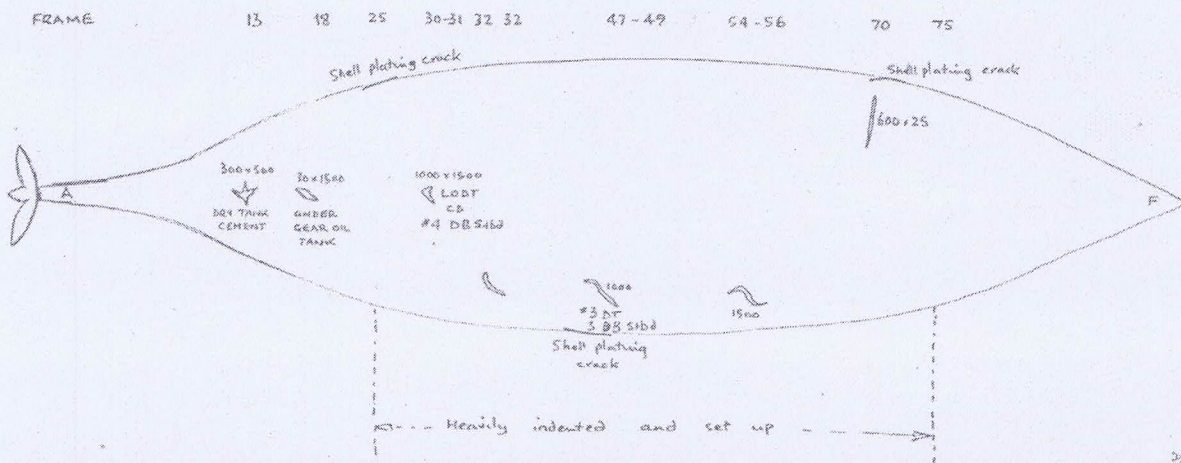
On Monday 14/12 an initial diving survey was carried out. This showed the vessel to be aground from just forward of the skeg to frame 75. An extensive crack was visible in the shell plating in a way of No 3 stb'd tank. The skeg did not appear to be damaged nor did the rudder. From the flooding in many double bottoms, deep tanks, engine room and No3 hold, it was evident that considerable bottom damage had occurred and it appeared that a number of bulkheads between tanks had suffered damage making tanks common.

On the morning of 22/12 and in the company of Mr Bob Hamilton, Tasmanian National Parks and Wildlife Officer and Mr Mike Lennon, I made a thorough inspection of offshore and foreshore areas in and adjacent to Garden Cove. All agreed that no oil pollution of consequence was apparent. At 0800 22/12 an underwater survey of the hull was carried out, this being simultaneously recorded on video tape for subsequent evaluation. This survey revealed extensive underwater damage the extent of which is shown approximately in attachment 3. (See below)
